# March 13, 1989 Geomagnetic Disturbance

On March 13, 1989, solar activity and the resultant geomagnetic disturbance (GMD) on the earth was responsible for widespread disturbances to the bulk electric systems in North America. This report will explain the GMD phenomenon and present in some detail the impacts of GMD on the electric systems.

## Hydro-Québec Blackout

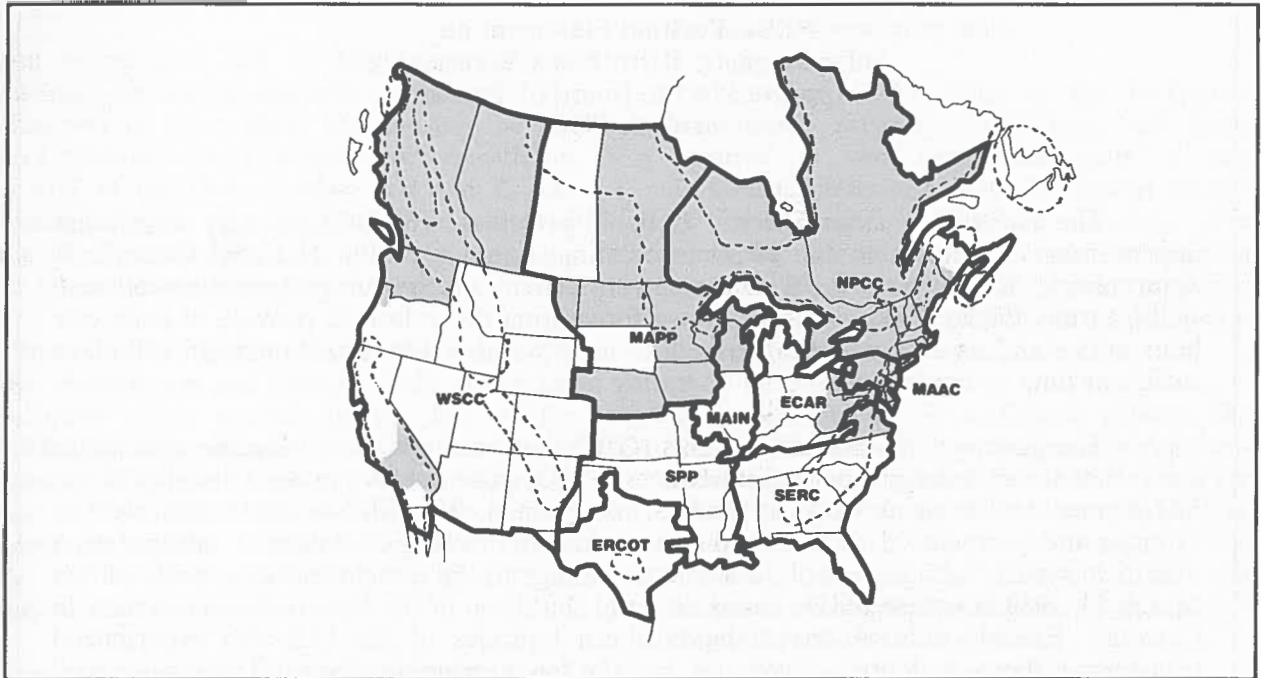
Figure 9 - States and provinces affected by the March 13, 1989 geomagnetic disturbance are shaded. Areas of igneous rock formations also shown.

In 1968, the Edison Electric Institute Board of Directors authorized support of research by the University of Minnesota and the General Electric Company to study the effects of geomagnetic storms on electric systems. This study reaffirmed that geological conditions tend to override the effect of latitude. Igneous rock resists the ground dissipation of GIC. The result is for this current to superimpose on the transmission network. Figure 9 shows the states and provinces in the U.S. and Canada that reported electric system disturbances from the March 13, 1989 solar storm. Note the relationships of the igneous rock and coastline to the reported events.

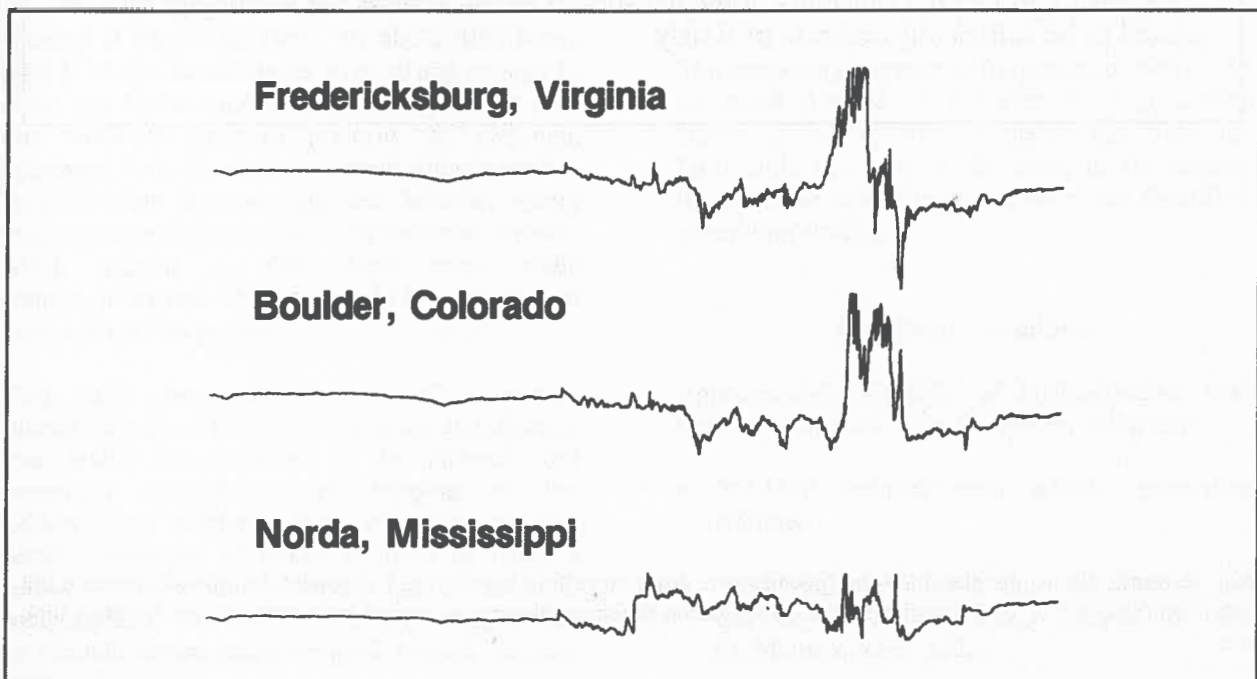
Figure 10 - Magnetometer readings from March 13, 1989 geomagnetic disturbance

geomagnetic field, latitude, geological conditions, and the position of the auroral oval (the more visual aurora borealis or "northern lights," the more intense the storm). Magnetometers are used in the U.S. and Canada to measure the geomagnetic field intensity in nanoTeslas (nT). Figure 10 shows the magnetometer readings of the horizontal axis of the geomagnetic field as measured at four locations on March 13, 1989. Note the variation in pattern and intensity at each location. Note also the relative difference in field activity between the early morning hours during which Hydro-Québec's blackout occurred and the late afternoon when significant electric system disturbances were reported in the U.S. These magnetometer plots also show the limitations of the "K" index.

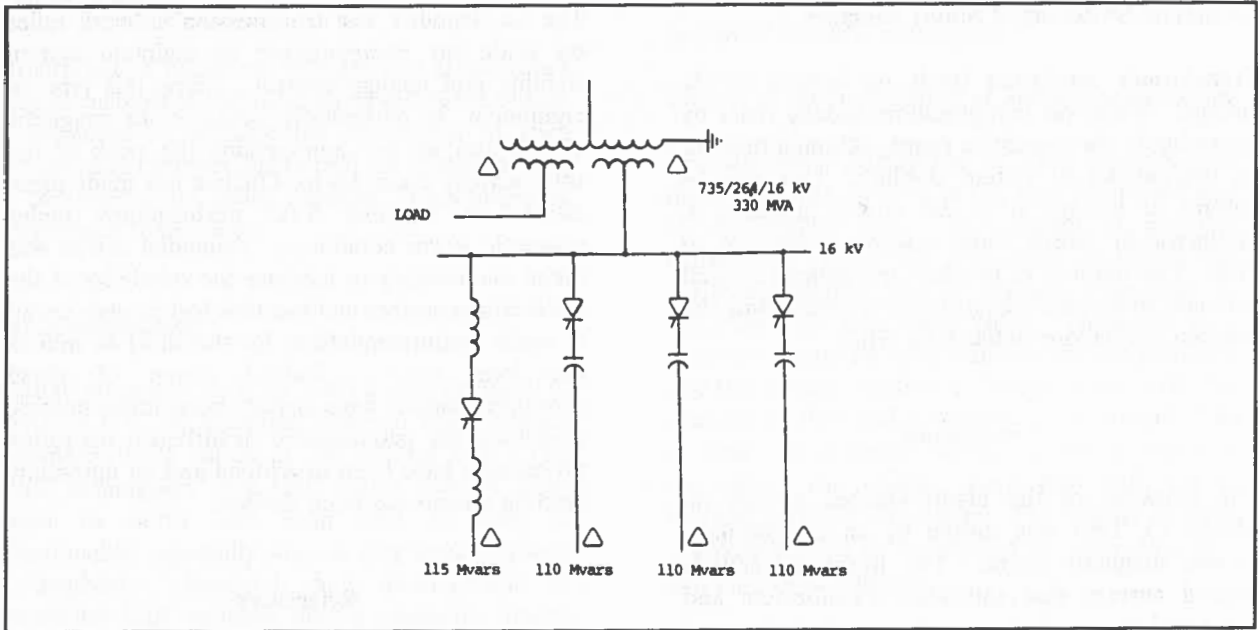
Figure 11 - One-line diagram of La Vérendrye-Chibougamau SVCs

Figure 11 shows a typical one-line diagram of SVC installations at the La Verendrye and Chibougamau substations. These SVCs were subjected to severely distorted voltage caused by geomagnetically induced dc currents (GIC).

Spectrum analysis of the waveforms recorded indicates predominance of second- and fourth-order harmonics resulting from dc saturation of transformer cores. Table 3 below shows the harmonic distortion content of voltage and current at La Verendrye prior to system shutdown. The equipment protection scheme was originally designed for normal conditions and the possibility of intense geomagnetic storms was not considered. With the exceptional disturbance of March 13, 1989, overload protection systems of the capacitive branches initiated tripping of the SVCs at the Chibougamau site. Figure 12 and Figure 13 show the distorted current waveform measured in the thyristor-switched capacitor branch prior to protection system operation.

At the La Verendrye site, overvoltage protection on the 16 kV bus side was responsible for tripping the only SVC in service. The components most sensitive to ground-induced currents are the capacitors, the thyristor-switched capacitor (TSC) reactors and the power transformers. Because of the low impedance of the capacitors for higher order harmonics, exposure to harmonic current has a greater impact on the TSC branch than the TCR branch. Given the abnormal conditions, the relays had to be readjusted, since the protection systems were set to values that allowed only a fraction of inherent overload capacity to be used. Peak-value overload and overvoltage protection is, in fact, provided for in these installations, but when

An increase in harmonic currents can affect the operation of relays sensitive to harmonics. To maintain normal operation of Hydro-Québec's static var compensators during geomagnetic conditions, settings for certain protective systems have been adjusted upward (see Table 5 and Table 6 on the following pages.) The new settings are only a short-term remedial measure to allow full use of the equipment's overload capability without having to deal with the problem of replacing all the relays. However, higher protection settings may accelerate aging of some static compensator components and of power transformers.

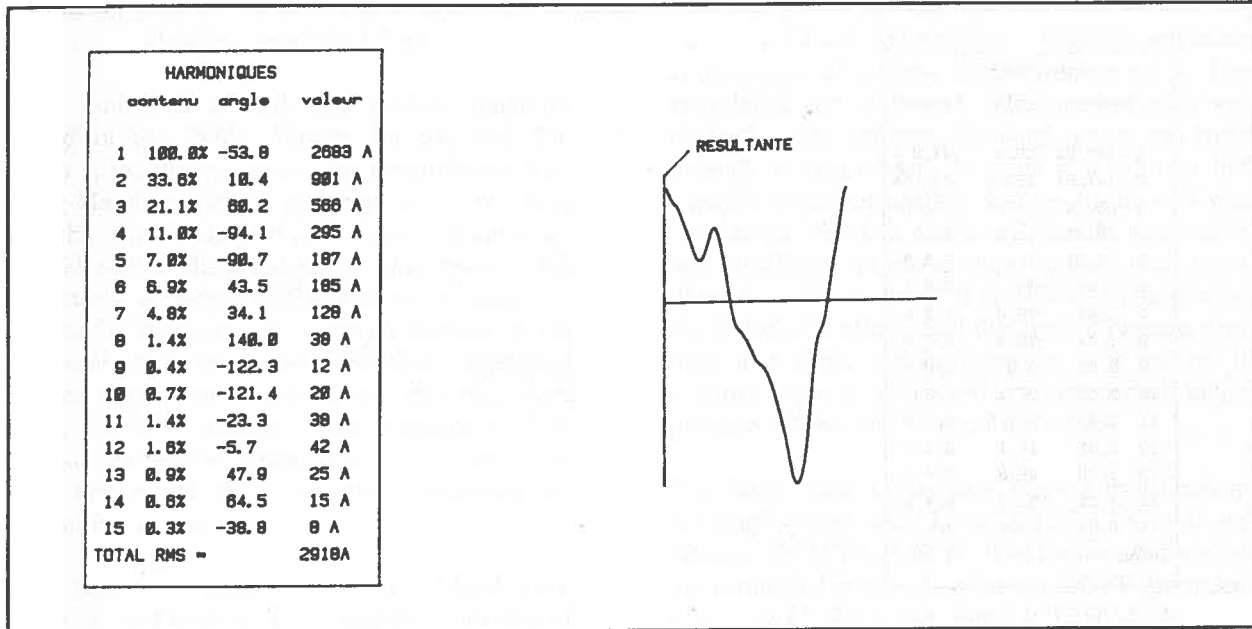
Figure 13 - Harmonic current at Chibougamau

<sup>1</sup> This protection initiated tripping of the SVC at the Chibougamau substation. Measured circulating current in the delta branch was about 1.5 p.u.

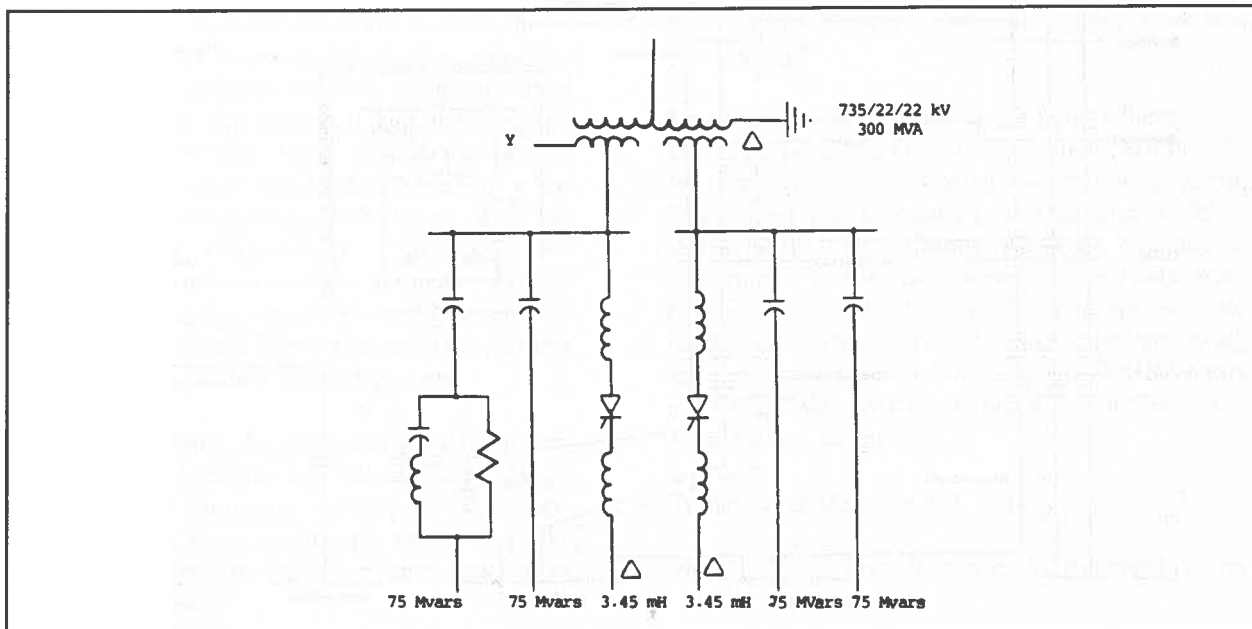
Figure 14 - One-line diagram of Némiskau/Albanel SVCs

Figure 14 shows a typical one-line diagram of SVC installations at the Nemiscau and Albel sites. These SVCs were tripped by capacitor unbalance and resistor overload protection devices of the third harmonic filter branch.

Unfortunately, the lack of a reading for the secondary 22 kV side of the static compensators at the time of the collapse made exact assessment of the stress on the SVC components impossible. The impact of voltage and current distortions on the 22 kV side was, therefore, determined theoretically. The findings thus obtained indicate values in excess of the settings of the protection devices that operated.

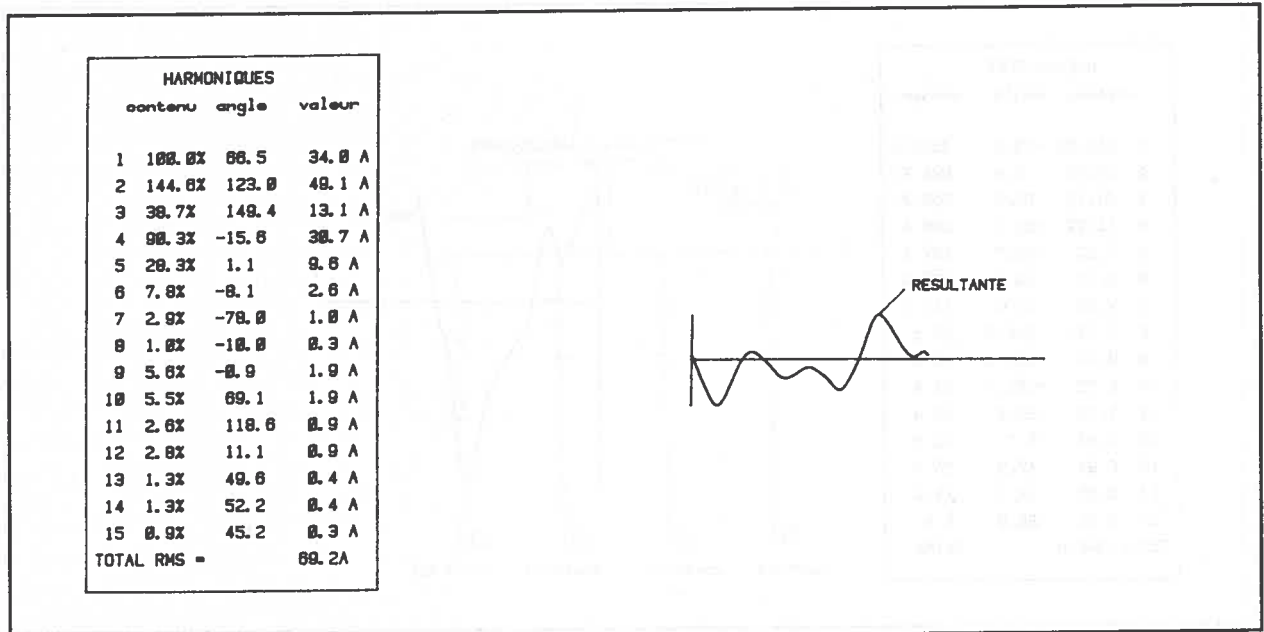
Figure 15 - Harmonic current at Albanel

As Table 4 shows, substantial second and fourth harmonic distortion was recorded on the 735 kV side of the Albel substation. Figure 15 shows the resultant current waveform on the high-voltage side just prior to tripping.

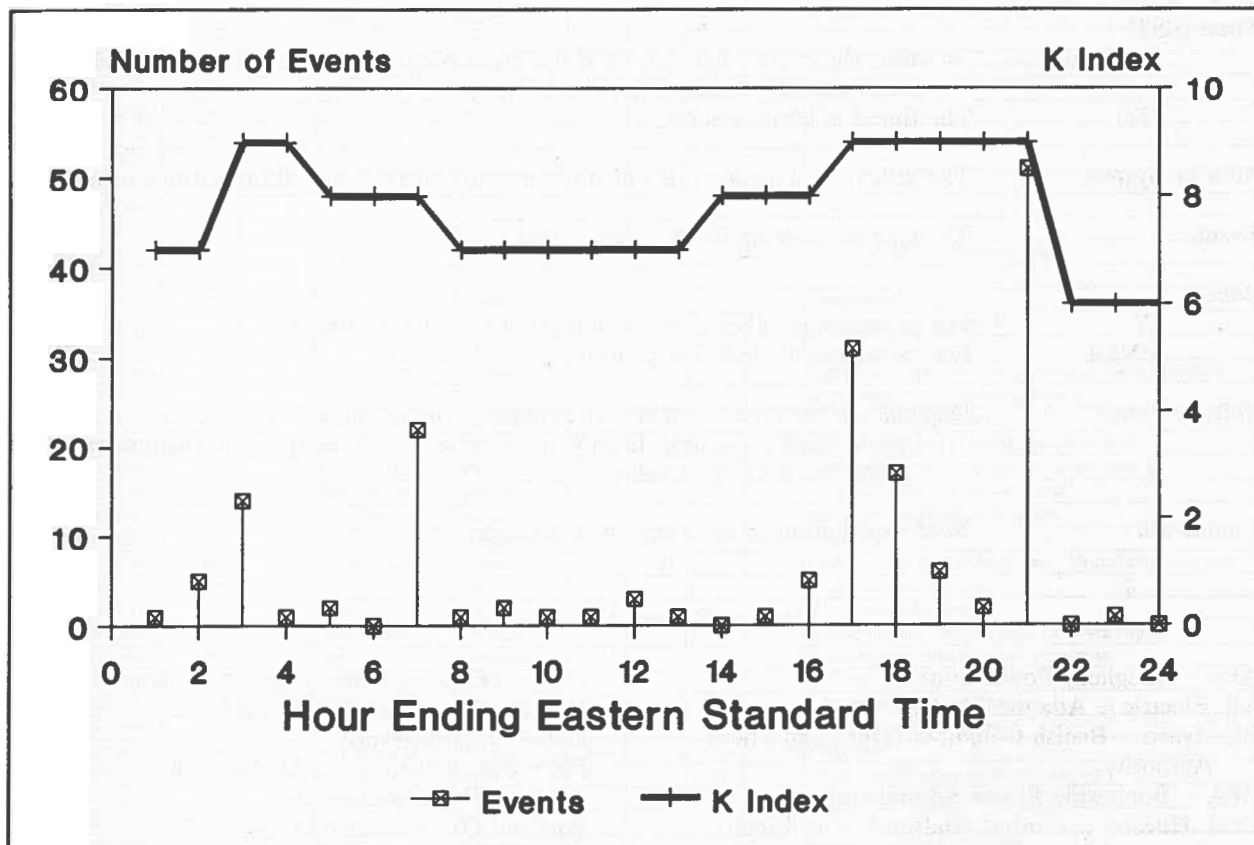
Graph 1 - Events and K intensity recorded during March 13, 1989 GMD

On March 13, 1989, there were two periods where geomagnetic intensity registered K9. Graph 1 on page 55 shows the relationship between the K index and events recorded on the bulk electric system due to geomagnetic activity on March 13.

Graph 1 is a histogram of the events that were recorded on March 13, 1989 related to the geomagnetic disturbance. These events are listed on the following pages.
