# March 13, 1989 Geomagnetic Disturbance

On March 13, 1989, solar activity and the resultant geomagnetic disturbance (GMD) on the earth was responsible for widespread disturbances to the bulk electric systems in North America. This report will explain the GMD phenomenon and present in some detail the impacts of GMD on the electric systems.

## Hydro-Québec Blackout

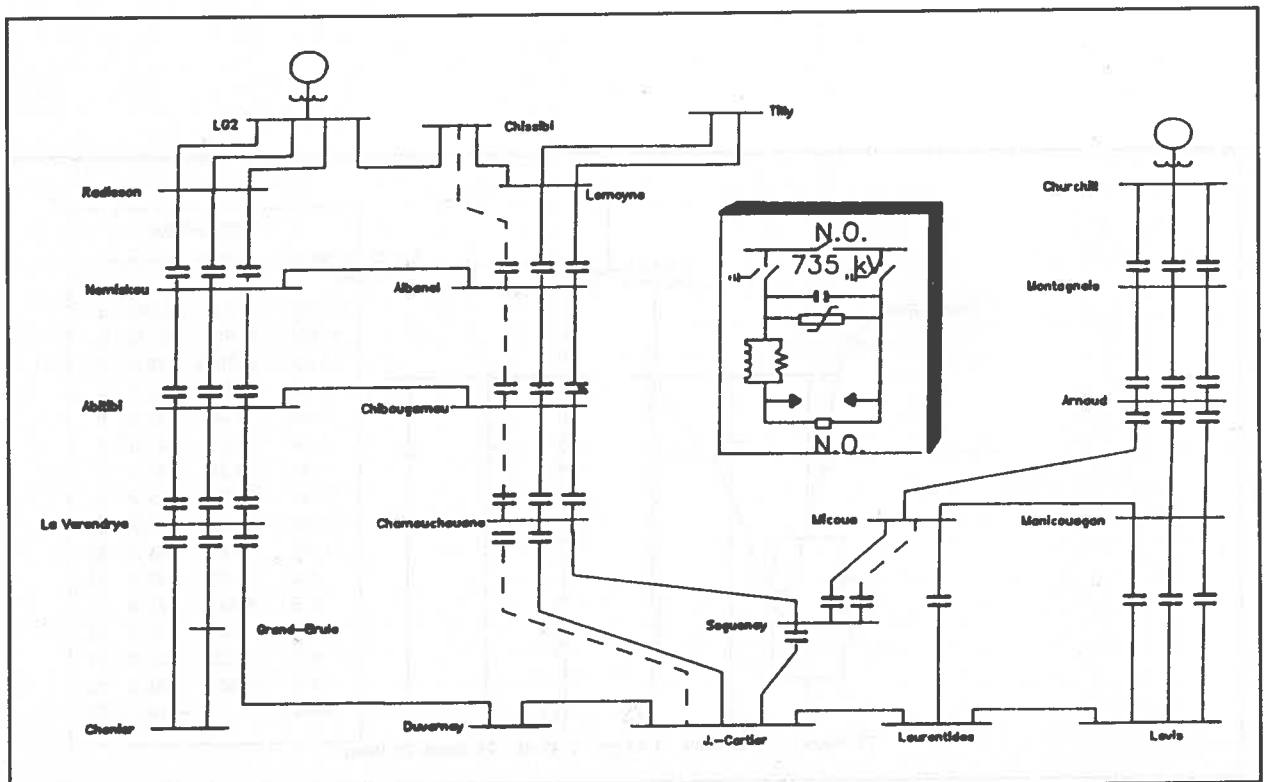
Figure 16 - Addition of series compensation to the Hydro-Québec transmission system

The scheduled installation of series compensation throughout the network in the near future will help to significantly reduce the impact of magnetic storms (see Figure 16). The series capacitors that are to be installed have a very high impedance for GICs and will thus block them. However, short lines and many tie lines will not be compensated, and this means creation of "loops" where GIC will continue to flow and to saturate transformers. This in turn will generate harmonics which will flow throughout the system, since they will not be blocked by series capacitors. The impact of series compensation is to be studied by evaluating GIC and harmonic voltages.
